## Tip of the Week – Preventing Risk

**CASE STUDY #13** PaSea H.EL.M.E.T. Marine Risk Assessment

**RISK ELEMENT:** Structural Condition of Internal Spaces

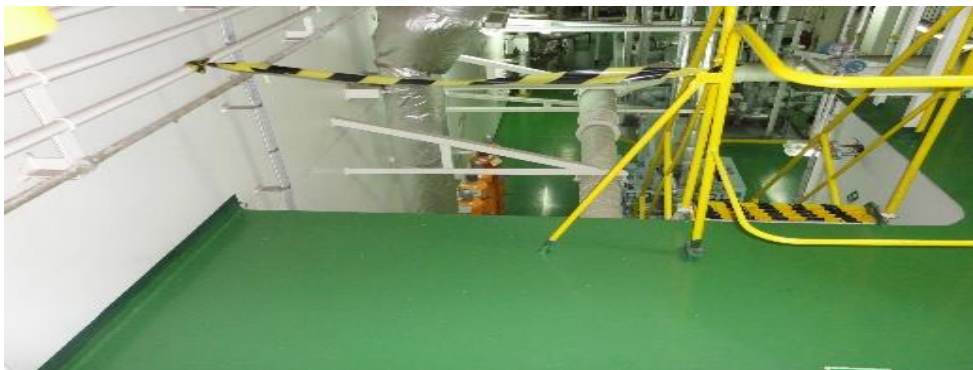
**MRA FINDING:** In the E/R first platform level on STBD side, a section of the railing was missing – a defect present since vessel Construction & Class approval. The crew placed a tiger color tape in order for the opening to be visible, undoubtedly a very dangerous fix where crew members can easily fall off by accident, during an emergency or rough sea.

**REF. SOLAS II-1/3.1**

**A PERMANENT CONSTRUCTION NEEDS TO BE PLACED a.s.a.p UNTIL THEN A WIRE ROPE NEEDS TO BE PLACED IN THIS OPEN SPACE WITH A VISIBLE SAFETY LABEL.**
