## Tip of the Week – Preventing Risk

**CASE STUDY #17** PaSea H.EL.M.E.T. Marine Risk Assessment

**RISK ELEMENT:** Permit to Work System & Engine Room's Safe Conditions

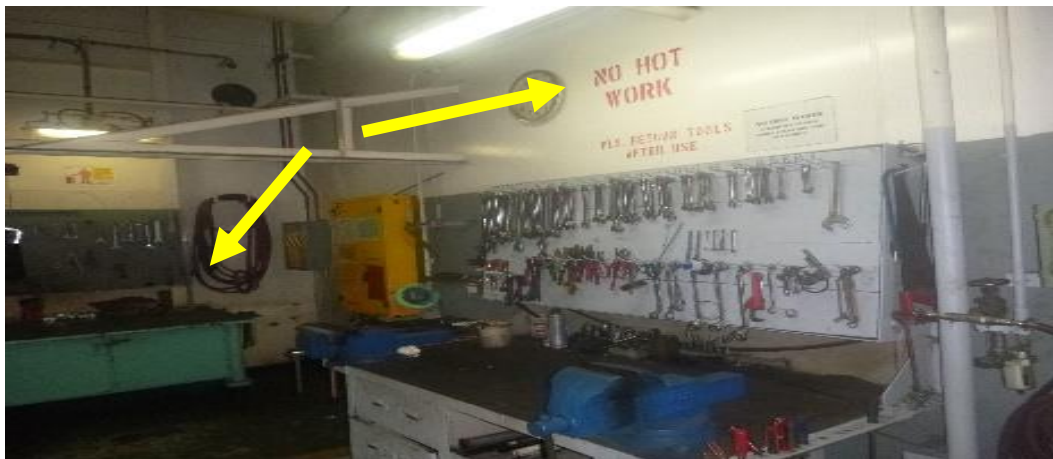
**MRA FINDING:** The welding area was next to an area in which Hot Work was NOT PERMITTED due to the Fuel Oil Tank's Bulkhead

**REF. IMO MSC/Circ.1084 – MSC.311 (88), ISGOTT Ch. 2.8 & SOLAS II-2/4**

**NO HOT WORK SHOULD BE CARRIED OUT WITHIN HALF A METER OF BULKHEADS OF BUNKER TANK, UNLESS THE TANK IS CLEANED TO HOT WORK STANDARD.**

**CREW MEMBERS LEVEL OF SAFETY AWARENESS SHOULD BE RAISED AND THE SAFETY CULTURE ON COMPANY MANAGED VESSELS SHOULD BE PRIORITY #1.**

**AT NEXT DRYDOCK THE RELOCATION OF THE WELDING AREA SHOULD BE CONSIDERED.**
