## Tip of the Week – Preventing Risk

**CASE STUDY #39** PaSea H.EL.M.E.T. Marine Risk Assessment

**RISK ELEMENT:** Pilot Transfer Arrangements

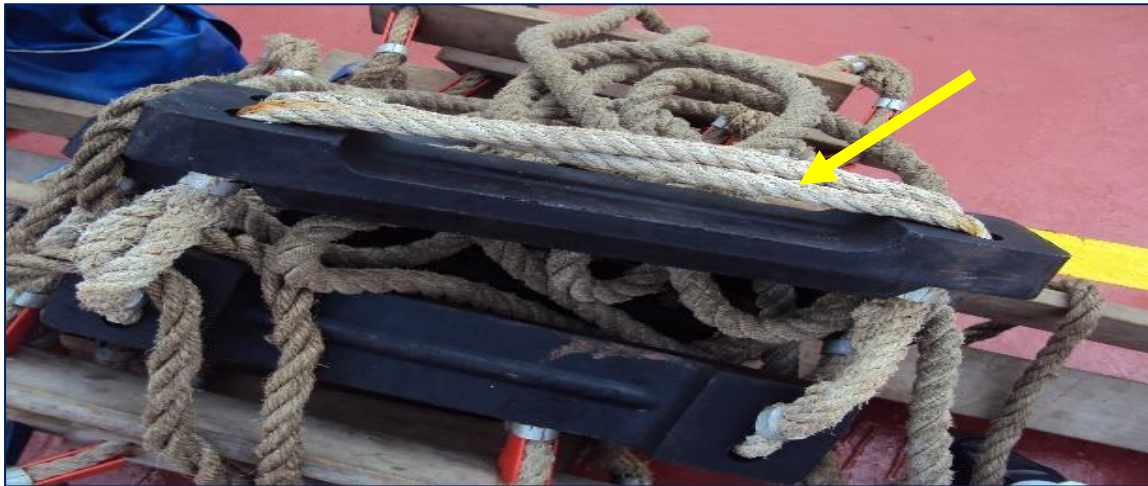
**MRA FINDING:** The rope connection of the lower step in the port-side Pilot Ladder was made with a different rope to the original side ropes that were in place

REF. SOLAS V/23, IMO Res a.1045 (27), BPG 5<sup>th</sup> EDITION p.94

THE SIDE ROPES OF THE PILOT LADDER SHOULD CONSIST OF TWO UNCOVERED ROPES NOT LESS THAN 18mm IN DIAMETER ON EACH SIDE AND SHOULD BE CONTINUOUS, WITHOUT JOINTS AND HAVE A BREAKING STRENGTH OF AT LEAST 24 KN (kilo newtons) PER SIDE ROPE.

REAGRDN THE ABOVE H.EL.M.E.T. MRA FINDING THE SIDES ROPES OF THE PILOT LADDER NEED IMMEDIATE REPLACEMENT AND PRIOR TO THIS REPLACEMENT THE LADDER MUST NOT BE USED FOR PILOT BOARDING.
