## INCORRECTLY SECURED OVERHEAD EQUIPMENT

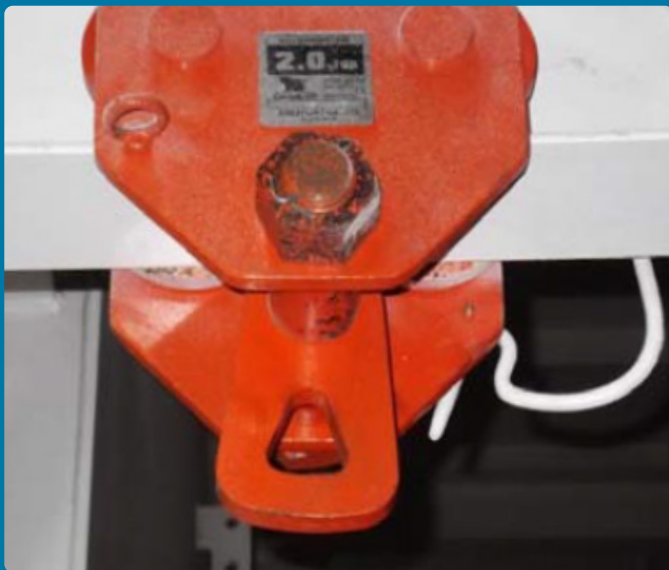
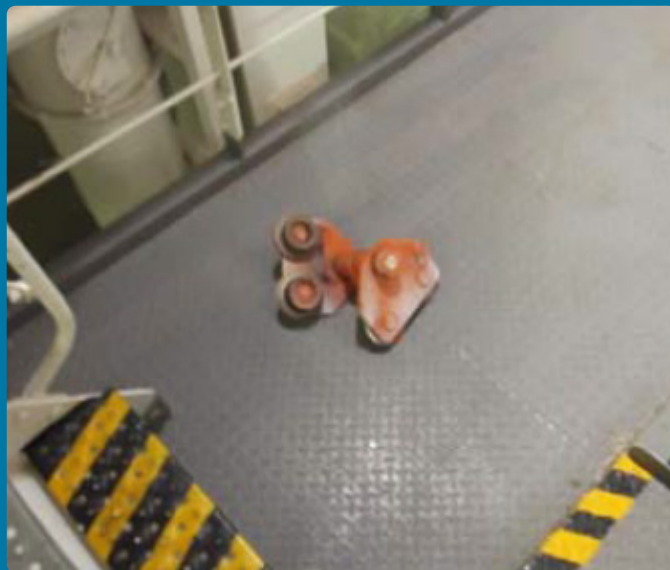
During an onboard Engine Room audit, the PAS Auditor observed the chain hoist trailer broken lying on the ER panels. No damage of equipment or crew injury was reported related to this incident. The PAS Auditor requested the crew to report this event as a near miss incident.

After investigation, it was found that the securing double nuts of the trailer were loose due to the vessel's vibration. The nuts were not secured with any form of securing system such as thread lock, spring washers or self-locking nuts or pins.

- Inspect the chain hoist trolleys to ensure all parts are in proper condition.
- Secure the trolleys in a safe position using locking pins or a falling preventive hook.
- Run a safety campaign to raise awareness about the possible defects and smooth operation with emphasis on the chain hoist trolleys in the Engine Room, and other spaces, where such equipment may be installed such as Inert Gas Room, Electrical Rooms, Cargo Machinery rooms, Pump rooms etc.
- Insert a task in the PMS database for periodical inspection of the overhead equipment.
