**Circular 01/02/14**

### ***Subject: Flame cutting - Important Occupational Safety/PSC Issue!***

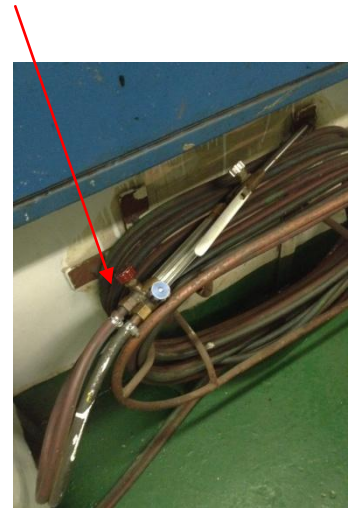
Case: Recently, a cargo vessel faced difficulties when the Port State Control Inspectors while inspecting the Engine Room noticed that the flame cutting gas hoses were not equipped with Flash Back arrestors (see picture). More specifically, the Port State Control Officers found that the subject equipment had been used several times in the past without the necessary precautions and only few engine crew members were aware of the use of the flash back arrestors. Finally, the vessel received the following deficiency:

“Flash back arrestors not fitted”, code 17

In the absence of an arrestor, the flame may travel extremely fast up to the gas supply hoses, to the regulator and possibly into the cylinders which in turn may cause explosion.

It is highly recommended, after each flashback incident, the arrestors, hoses and fittings to be inspected for damage and if necessary to be discarded or repaired according to the maker’s instructions.
