**Circular 02/07/2015**

**Subject: “International shore connection not kept/placed at marked location” - Important PSC Issue!**

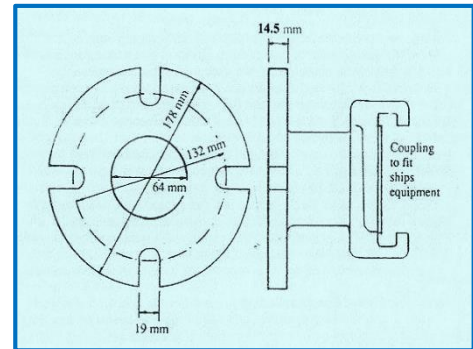
- The connection should be made of steel or other suitable material and should be designated for 1N / mm<sup>2</sup> services. The flange should have a flat face on one side, and on the other side, to be permanently attached to a coupling that will fit the vessel's hydrant and hose.
- The connection should be accompanied with a gasket (suitable for 1N/mm<sup>2</sup> services), four (4) bolts (16 mm diameter & 50 mm in length), nuts (16 mm) and eight (8) washers.

- **The shore connection should be located in a readily accessible location.**
