# DON'T CURE PREVENT

ISSUE 03

JUNE 2020

**FIRE DETECTION  
SYSTEM ZONE  
ISOLATION**

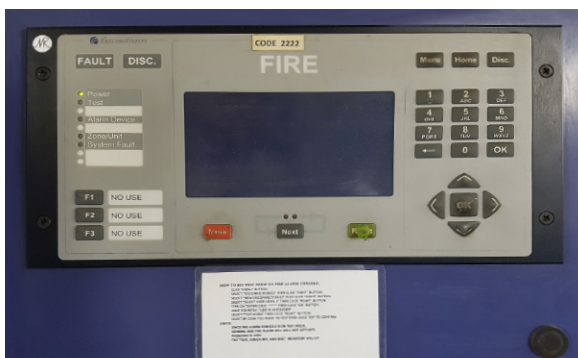
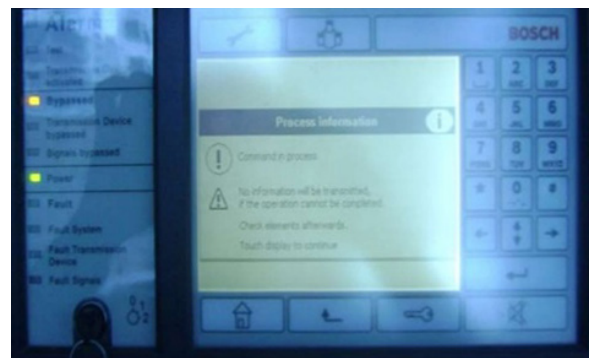
During an onboard H.EL.M.E.T. assessment, the P@S Assessor noticed that a fire detection zone corresponding to the Engine workshop had been isolated. More specifically, the subject zone had been bypassed from the fire detection's system panel without prior notification to the crew members. After investigation, it was identified that the said fire zone had been isolated for hot work purposes. With the aim to raise awareness, the HELMET Assessor emphasized to the seafarers the importance of keeping the fire zones active at all times whilst specific reference was made to regulations. The status of the said zone was reinstated according to Assessor's instructions.

*At the next port of call few weeks later, while the engine room was unmanned, the said zone was found again isolated which in turn resulted in the vessel's detention by the PSC Inspector.*

- The procedures established by the company's SMS did not promote raising of awareness.
- Willful ignorance and negligence by the person-in-charge despite the clear SMS procedures.
- The Crew member underestimated the risks of isolating a fire detection zone without forewarning or informing the relevant personnel.
- The safety precautions in regards to hot work operations were not taken as the relevant work flow was not followed.
- Absence of safe business culture.

- Implement the relevant hot work permit's work flow.
- Double check that all precautionary measures are in place before commencement of relevant operation.
- Always bear in mind that "the unexpected" could occur.
- Report any defect upon identification.
- Raise awareness of the possible risks.
- Increase risk perception amongst the crew.
