## MISLEADING SAFETY SIGNAGE & IMPROPER STORAGE OF FUEL SAMPLES (When a Lifejacket Box isn't what it seems...)

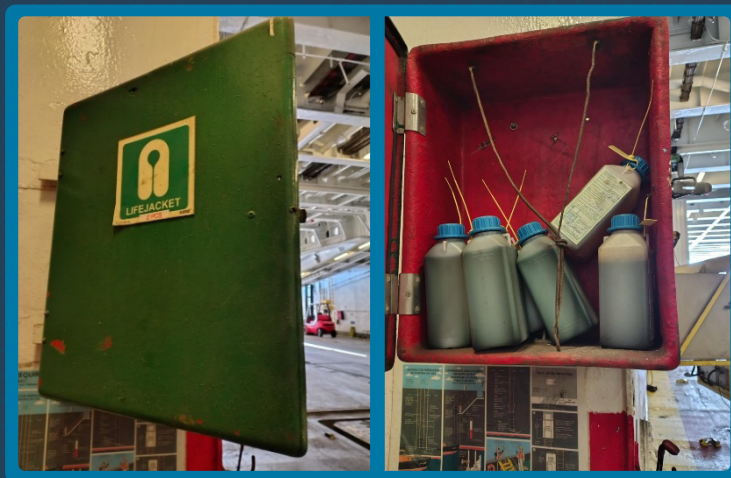
During an onboard PSC Preparation, the PAS Auditor observed a storage box on deck clearly marked with the IMO symbol for lifejackets, indicating that emergency life-saving equipment was stored inside. However, when opening the box, the auditor found that it contained fuel oil samples retained by the Engineering Department. This storage practice is misleading and potentially hazardous. In the event of an emergency, crew members may waste critical time searching for lifejackets that are not in their designated locations, thereby compromising the effectiveness of evacuation process and overall safety onboard.

- Ensure that all signage accurately reflects the actual contents of each box, locker, or storage compartment.
- Conduct regular safety rounds to verify that markings, signage, and equipment locations are correct and consistent throughout the vessel.
- Promote effective communication between departments to prevent misunderstandings regarding space usage and responsibilities.
- Incorporate signage verification as part of routine onboard safety inspections and internal audits.
- Use this incident as a case study during safety meetings to reinforce situational awareness and good safety practices.
