## Tip of the Week – Preventing Risk

**CASE STUDY #24** PaSea H.EL.M.E.T. Marine Risk Assessment

**RISK ELEMENT:** Portable Gas Detection Equipment

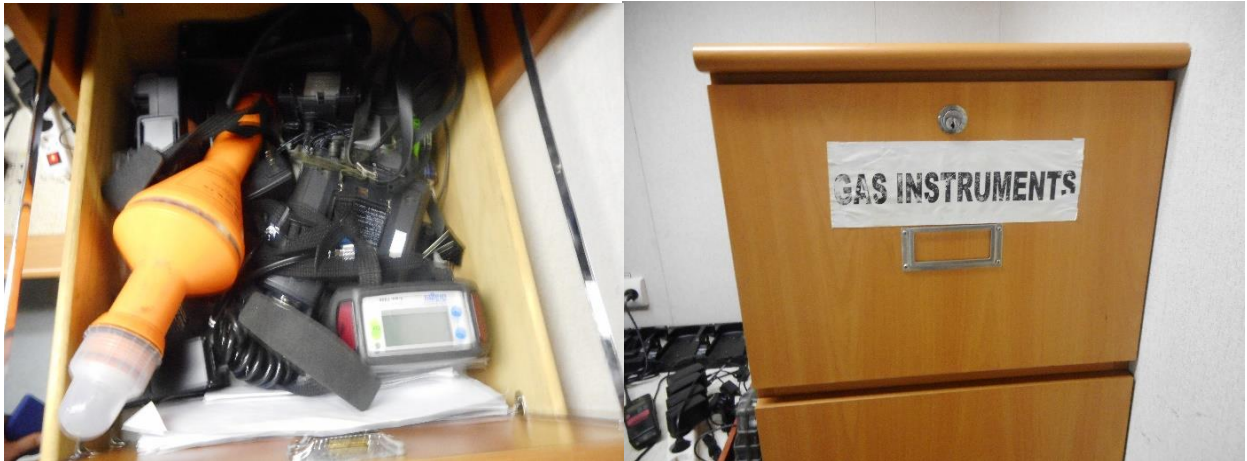
**MRA FINDING:** A safety light from the LSA equipment was found in the Gas Instruments drawer

**THIS FINDING INDICATES IMPROPER HOUSEKEEPING AND STORAGE OF VITAL EQUIPMENT. IMPROPER STORAGE OF SUCH EQUIPMENT OTHER THAN NOT MAKING THEM READILY AVAILABLE CAN CAUSE DAMAGE TO THEM AND IMPACT THEIR FUNCTIONALITY.**

**IN ORDER TO ENSURE THE GOOD FUNCTIONALITY OF SUCH EQUIPMENT ONBOARD, IT IS SUGGESTED THAT PROPER HOUSEKEEPING PROCEDURES ARE FOLLOWED. TRAINING FOR THE CREW REGARDING PROPER STORAGE & USE OF SUCH EQUIPMENT IS VITAL...**
