**CASE STUDY #29** PaSea H.EL.M.E.T. Marine Risk Assessment

**RISK ELEMENT:** Safe Mooring Arrangements

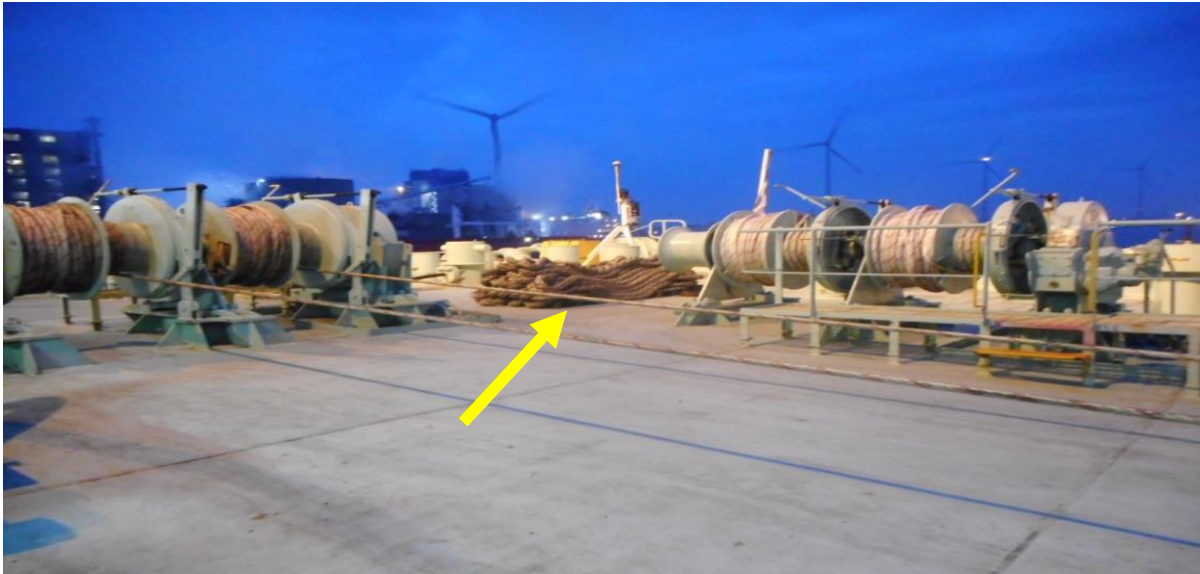
**MRA FINDING:** Different type of mooring rope was found on standby in the aft mooring station, ready to be used if additional rope is needed.

WHERE MIXED MOORINGS ARE USED THE LOW STIFFNESS FIBRE LINES WILL CARRY ALMOST NO LOAD WHILE THE HIGH STIFFNESS LINES SUCH AS HMSF LINES WILL BE HEAVILY LOADED AND THIS COULD DAMAGE THEM CAUSING THEIR EARLY RETIREMENT OR EVEN WORSE THE MOORING LINES BREAKING.

IT IS SUGGESTED TO AVOID MIXED MOORING OPERATIONS BECAUSE SUCH PRACTICES ACTIVELY COMPROMISE THE VESSEL'S SAFETY.
