# DON'T CURE PREVENT

**ISSUE 01** FEBRUARY 2020

## MOORING EQUIPMENT MAINTENANCE

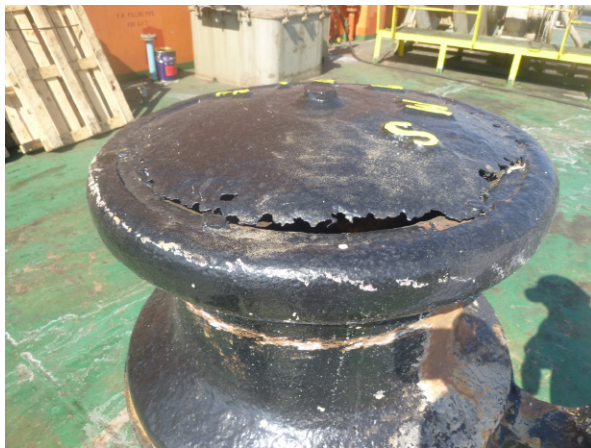
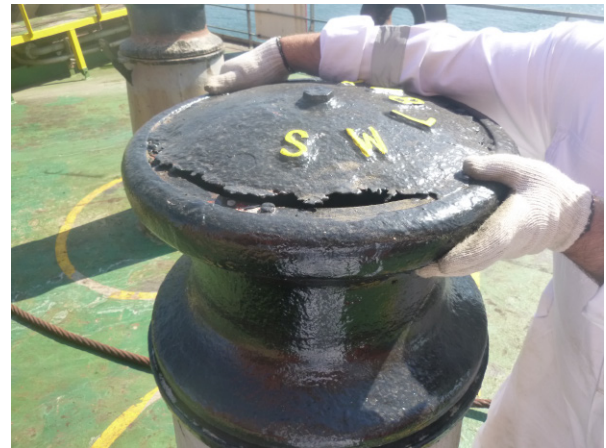
During a H.E.L.M.E.T. assessment onboard a vessel, the P@S Assessor evidenced serious damage on the ship's mooring rollers. More specifically, the rollers were found rusty and corroded. During the assessment, vital mooring equipment was also found in poor condition. Such condition was highlighted by the Assessor as constituting an unsafe business culture.

*This resulted in vessel's detention by the PSC Inspector few weeks later.*

- ❏ The periodical inspection of mooring equipment as per Company's Policy had not been conducted, as it was recorded, on a regular basis.
- ❏ Maintenance on the Mooring Equipment was not as per best practice.
- ❏ The Crew members underestimated the importance of well maintained Mooring Equipment.
- ❏ Safety precautions in regards to mooring operations were not taken.
- ❏ Absence of Safe business Culture was observed.

- ⦿ Check the condition of Mooring Equipment as per Company's Procedures.
- ⦿ Check that the mooring lines' condition is satisfactory in order for the mooring operation to be conducted in a safe manner.
- ⦿ Conduct periodical maintenance as per manufacture's instructions.
- ⦿ Report any defect upon identification and apply necessary correction or rectification plan.

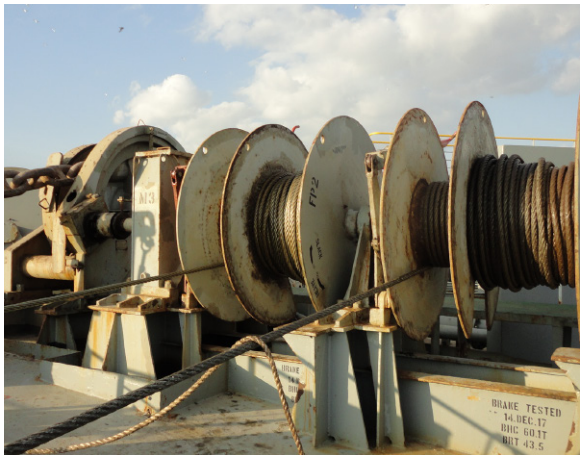
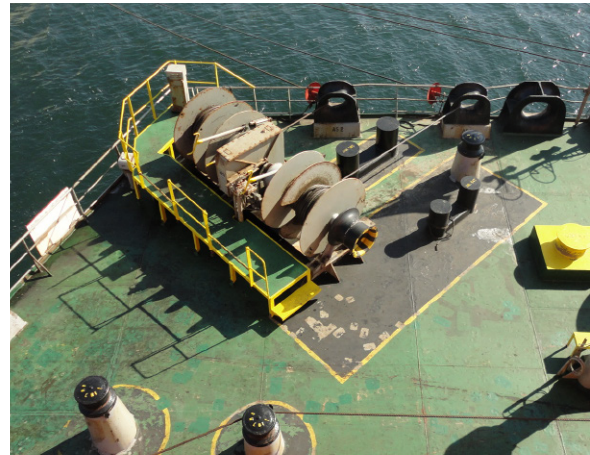
*Note: Mooring equipment that has suffered severe wastage will not perform to the certified standard.*
