PREVENTION AT SEA

ISSUE 20

APRIL 2023

# SAFETY HARNESS

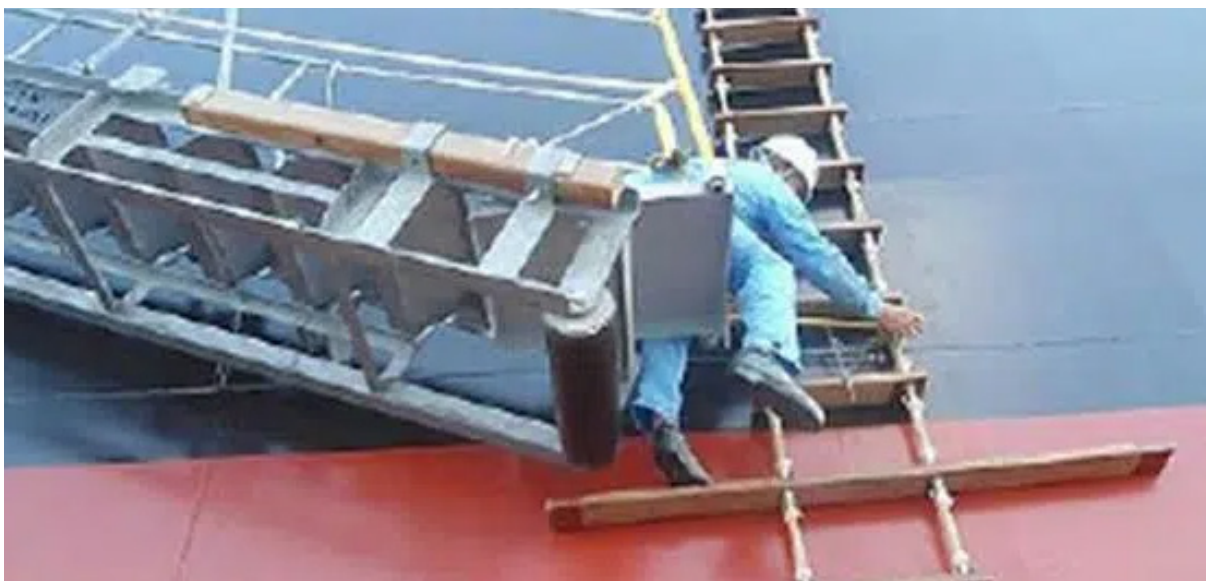
While the PAS Assessor was conducting a real time navigation audit, an improper set up of the gangway was observed. More specifically, while the deck crew was deploying the gangway ladder, an AB was observed walking along the gangway without having attached their harness at a secured spot/position (on the ship's or ladder's rail). Moreover, when the Deck Officer on watch noticed such an unsafe action, he immediately instructed him to attach the harness at ship's rail whilst at a later stage the AB disclosed that he was instructed to cross the ladder without receiving specific and clear safety rules.

*The subject unsafe behaviour is considered critical and opposed to the company's safety culture and behavioral awareness program.*

- 🕒 Highlight the vital importance of the proper use of PPE.
- 🕒 Carry out toolbox meeting prior every work on deck.
- 🕒 Emphasize, as a supervisor, the correct utilization of the PPE.
- 🕒 Ensure proper supervision during the preparation of boarding arrangements.
- 🕒 Ensure understanding by the seafarers of the vital role of the Safety Culture and good seamanship.
