# PREVENTION AT SEA

CIRCULAR 05/2019

“OILY WATER SEPARATOR –  
DO NOT GET EXPOSED”

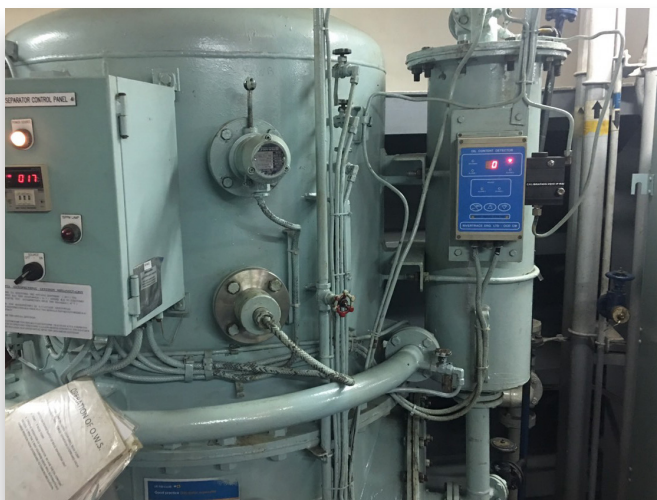
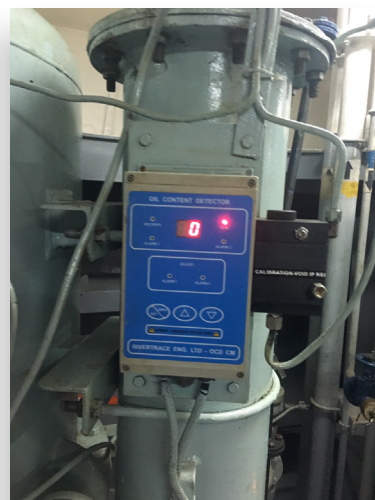
**Case#1:** During a H.E.L.M.E.T. audit on a tanker vessel, the PaSea Auditor observed that the Oily Water Separator (OWS) was malfunctioning due to an issue with the three way valve not properly working. It was also noticed that the Engine Crew was not familiar with the general operation of the OWS as well as how to extract data from the recording device. The PaSea Auditor explained to the Master & Engine Crew the seriousness of the situation in addition to noting it in the audit report.

The 15ppm Bilge Alarm should record date, time and alarm status and operating status of the 15 ppm Bilge Separator. The recording device should also store data for at least 18 months and should be able to display or print a protocol for official inspections as required. In the event the 15ppm Bilge Alarm is replaced, means should be provided to ensure the data recorded remains available on board for 18 months.
