# DON'T CURE PREVENT

ISSUE 11 OCTOBER 2021

THE PROPER HANDLING  
OF GAUGING DEVICES

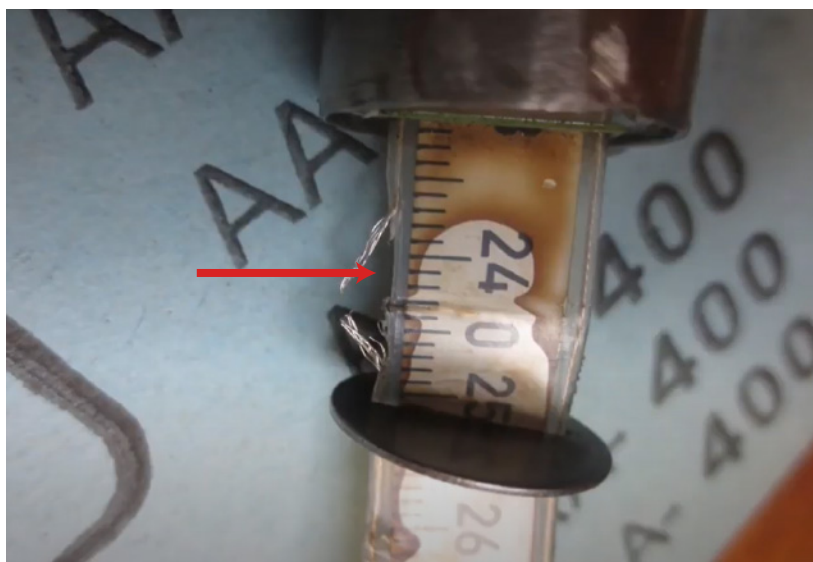
During an onboard Cargo Operation Audit the crew members were performing a loading operation. P@S Assessor observed that during the most critical point of the topping off, one of the three UTI\* portable gauging device runs out of battery and the ullage indicator of the second portable gauging device was damaged. As a result, the crew progressed with the topping off by the fixed gauging system and with only one UTI tape. P@S Assessor observed also, that the pre-arrival checklist, as per company's procedures, related to Cargo equipment was completed 24 hours prior to arrival.

*The subject observation comprises a common finding, which may lead to complications during PSC inspections, vetting inspections or class inspections, if crew is dependent only on the fixed gauging system and do not use properly the UTI or \*\*MMC tapes during the loading procedure.*

- 🕒 The Company should prepare a specific cargo operation letter for the importance of the proper handling of UTI sounding tape as they are sensitive equipment.
- 🕒 The company should deliver extra training to the Senior Officers in order to understand the real meaning and culture of the checklist's compliance.

- ✅ Chief Officer should actually check the cargo equipment prior to arrival at Discharging/Loading port as it holds a critical role for the safe conduct of cargo operation.
- ✅ Chief Officer and Safety Assistance Officer should always supervise the ratings for the appropriate storage conditions and cleaning of the portable cargo equipment.
