# DON'T CURE PREVENT

ISSUE 17 OCTOBER 2022

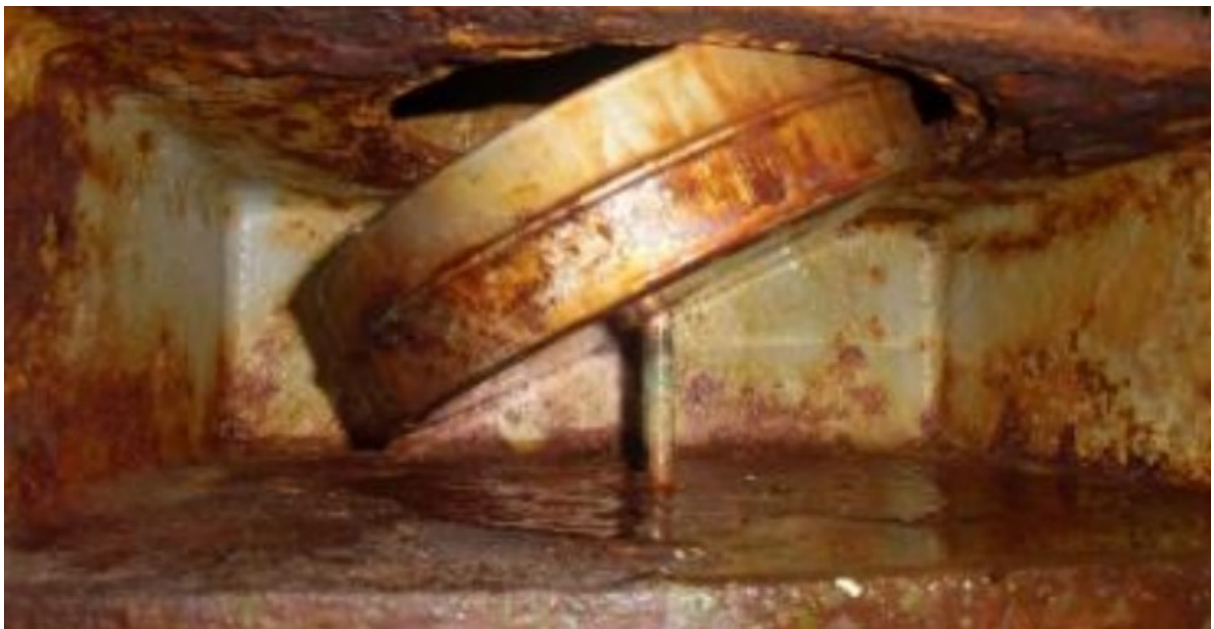
### REGULATORY FRAMEWORK

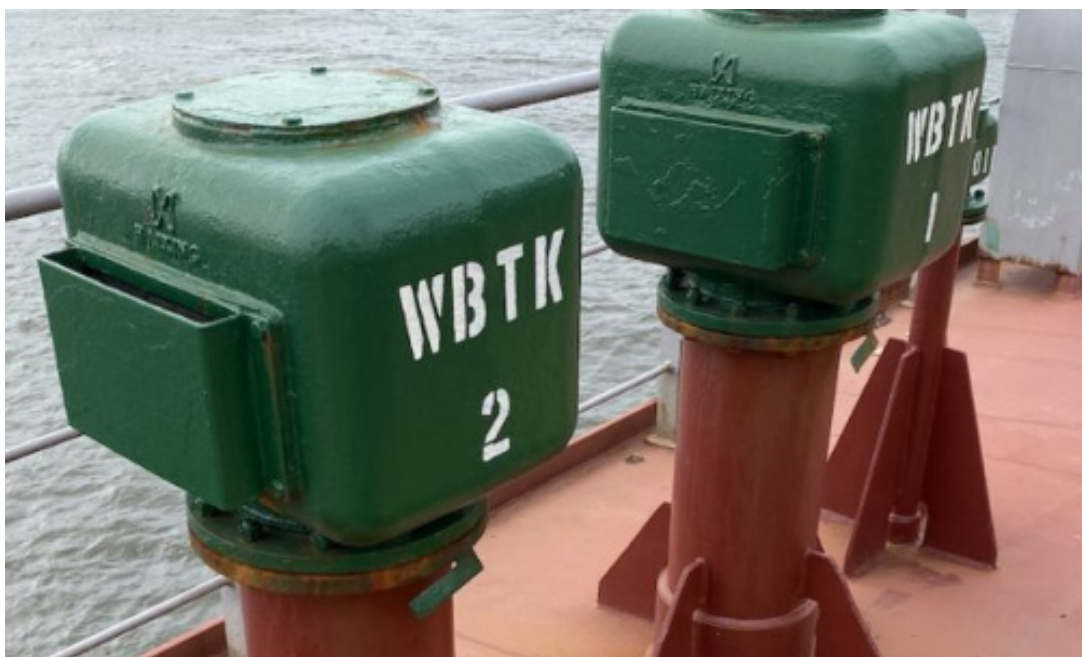
- 🕒 Highlight the vital importance of proper maintenance of the closing devices in the ballast vent heads.
- 🕒 Follow Company's procedures regarding inspection and maintenance of ballast air vent heads.
- 🕒 Ensure proper monitoring of such equipment during deck inspection.
- 🕒 Provide extra training to the Senior Officers for understanding the reason of air vents existence and improving safety behavior.
