# DON'T CURE PREVENT

ISSUE 25 DECEMBER 2024

## LIFEBOAT DAMAGES DURING DRILLS

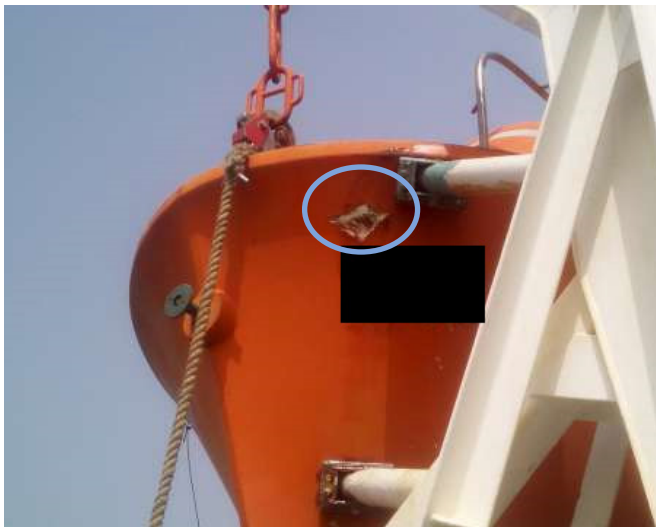
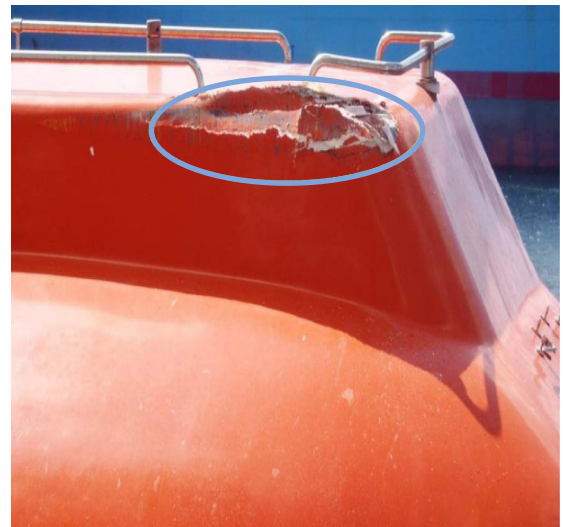
During the lifeboat launching, the cradle stopper of the forward davit failed to open. As a result, the lifeboat started swinging, making forceful contact with the vessel's fish plate.

The lack of proper maintenance and adherence to inspection intervals can compromise personnel's safety and vessel's condition. If not addressed, this could reflect inadequate hazard identification and reduce vessel's readiness during emergencies.

The PAS Auditor provided on-the-job training and familiarization with proper lifeboat launching procedures as well as on-site assistance in relation to the maintenance of the davit and its components, including the cradle stopper.

- 🕒 Exercise critical thinking.
- 🕒 Ensure that assigned personnel conduct onboard inspections at proper intervals, as scheduled.
- 🕒 Promptly identify and address the required maintenance of onboard lifesaving equipment without delay.
- 🕒 Do not forget to test the launching appliances on a weekly basis and as per manufacturer's guidelines to verify their proper operation.
- 🕒 Ensure that the personnel in lifeboat is trained and familiar with the lifeboat lowering procedures.
- 🕒 Risk assess and review its results with all involved personnel before commencing the drill. Consider the prevailing weather conditions and any existing equipment defects.
