# DON'T CURE PREVENT

ISSUE 03

JUNE 2020

**FIRE DETECTION  
SYSTEM ZONE  
ISOLATION**

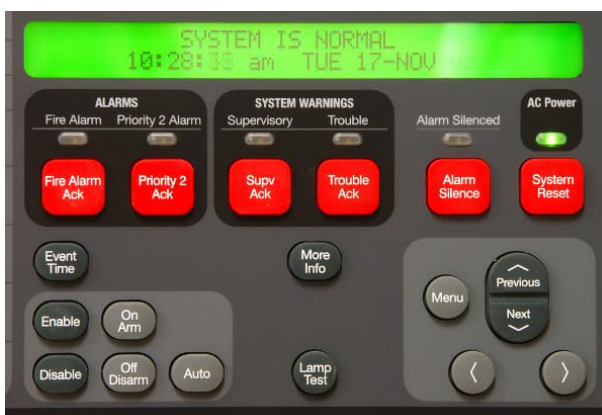
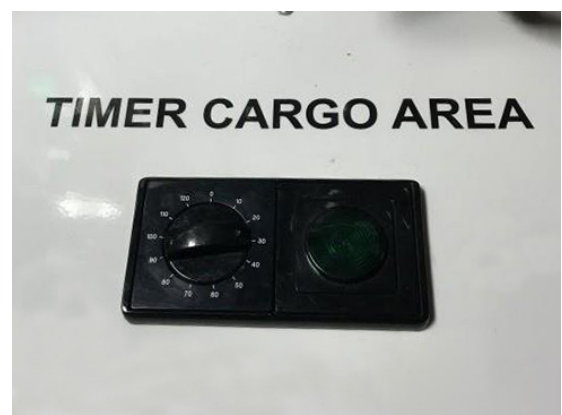
*Note: Isolated fire zones could be forgotten in bypass mode rendering the space vulnerable.*

- Implement the relevant hot work permit's work flow.
- Double check that all precautionary measures are in place before commencement of relevant operation.
- Always bear in mind that "the unexpected" could occur.
- Report any defect upon identification.
- Raise awareness of the possible risks.
- Increase risk perception amongst the crew.
