## Tip of the Week – Preventing Risk

**CASE STUDY #15** PaSea H.EL.M.E.T. Marine Risk Assessment

**RISK ELEMENT:** Human Element / BBS – Occupational Safety

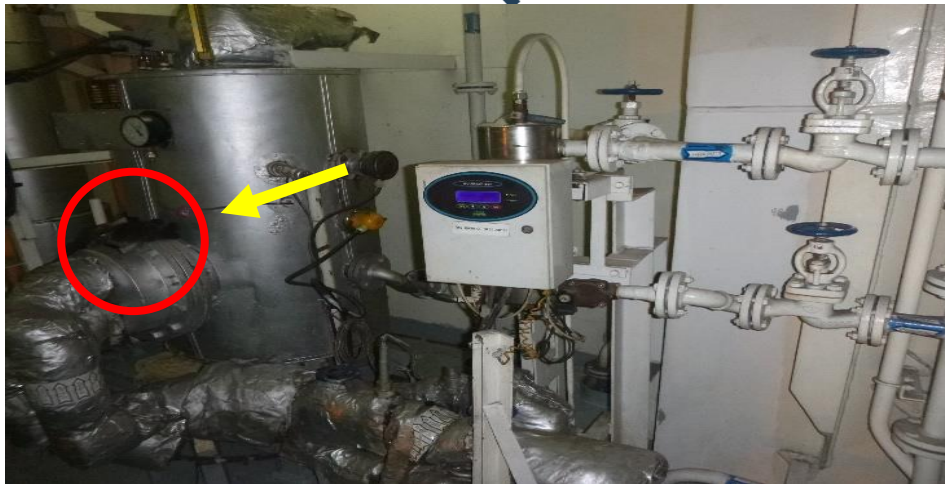
**MRA FINDING:** Observed that a pair of gloves was left behind on a hot surface area.

**CREW MEMBERS HAVE NEED TO BE EXTRA CAUTIOUS WITH HOT SURFACES. FLAMABLE MATERIAL SHOULD NOT BE PLACED NEAR OR ON TOP OF SOURCES OF HEAT.**

**IT IS VITAL TO ENSURE THE CREW'S AWARENESS REGARDING FIRE PRECAUTIONS & SAFETY AND TRAINING AND/OR FAMILIARIZATION TO BE PROVIDED WHERE NEEDED.**
