## Tip of the Week – Preventing Risk

**CASE STUDY #19** PaSea H.EL.M.E.T. Marine Risk Assessment

**RISK ELEMENT:** Marking & Identification of LSA & FFE

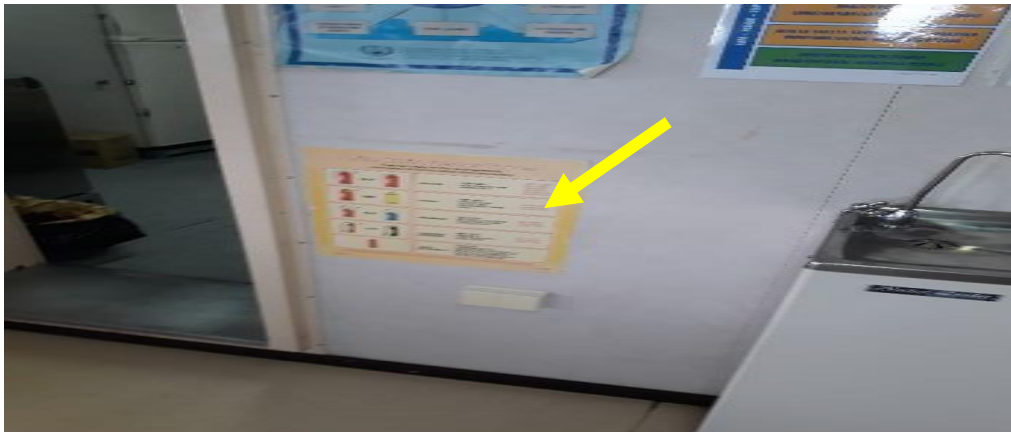
**MRA FINDING:** Several IMO fire control posters contained previous resolutions

**CREW WAS NOT UPDATED WITH LATEST LSA & FFE RESOLUTIONS. THIS COULD BE AN OBSERVATION BY PSC INSPECTORS AS WELL AS 3<sup>rd</sup> PARTY AUDITORS NOTING THAT THE COMPANY LACKS PROCEDURES TO CONTROL SUCH MATTERS**

**ALL LSA & FFE POSTERS ONBOARD NEED TO BE REPLACED AS SOON AS UPDATED ONES ARE RELEASED. CREW NEEDS TO BE AWARE OF NEW SAFETY SIGNS & SYMBOLS AND REGULATIONS/RESOLUTIONS**
