## Tip of the Week – Preventing Risk

**CASE STUDY #31** PaSea H.EL.M.E.T. Marine Risk Assessment

**RISK ELEMENT:** Navigational Equipment, Systems & Housekeeping

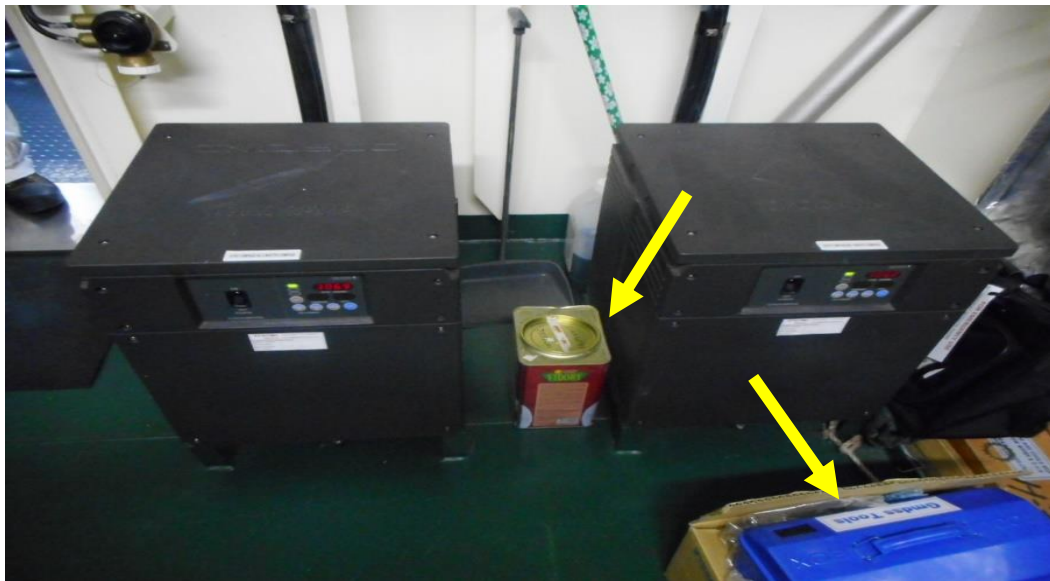
**MRA FINDING:** Two loose items (one of them a toolbox for GMDSS equipment) were found inside the Bridge locker near the gyro compasses.

**THE SPECIFIC TWO LOOSE ITEMS COULD CAUSE SERIOUS DAMAGE TO THE GYRO COMPASSES IN CASE OF ROLLING WHILE THE VESSEL IS UNDERWAY.**

**IT IS SUGGESTED THAT LOOSE ITEMS ARE NOT PLACED NEAR SENSITIVE EQUIPMENT. LOOSE ITEMS SHOULD BE STORED SECURELY AT ALL TIMES AND ESPECIALLY WHEN THE VESSELS IS UNDERWAY. AWARENESS AMONG CREW MEMBERS IS ESSENTIAL ON SUCH MATTERS AND SUCH PRACTICES SHOULD BE AVOIDED.**
