## LIFEBOAT DAVIT WINCH MAINTENANCE

### INCIDENT

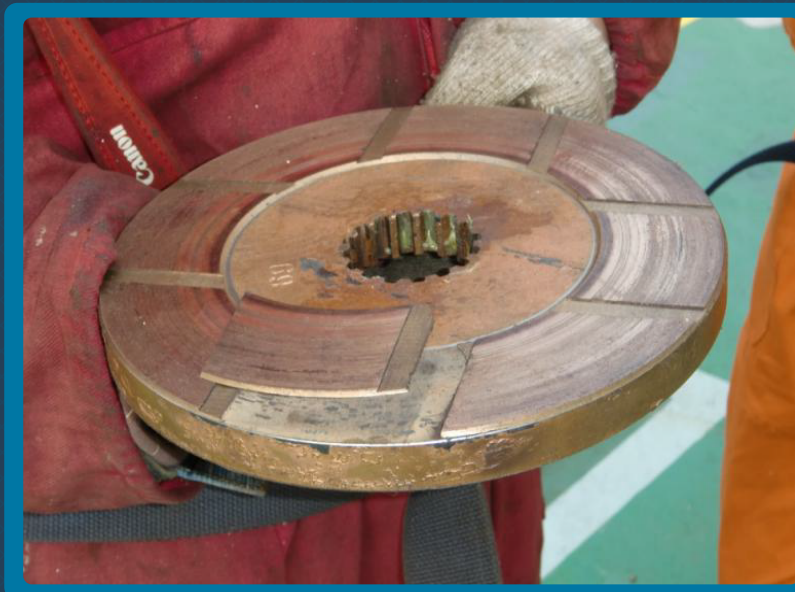
After investigation it was found that part of the sintered copper brake lining of the static brakes had been parted from the support plate. When the subject lining is detached from the backing plate, a static brake failure may occur, resulting in a potential injury, damage, or loss of the lifeboat.

- Record the condition of the static brakes during the annual planned maintenance inspection.
- Be accurate by avoiding the recording of comments such as “checked” or “done” without detailed explanation.
- Always retain at least one spare brake disc onboard.

- Run a safety campaign to raise awareness about the possible defects and smooth operation of the lifeboats’ winch brakes.
- Check that the PMS calls for inspection of the brake lining area during the annual and 5 yearly maintenance cycle.
- Ensure compliance with the manufacturer’s instructions related to maintenance and replacement of critical parts.
