## BLOCKING OF F.O. BUNKER LINE

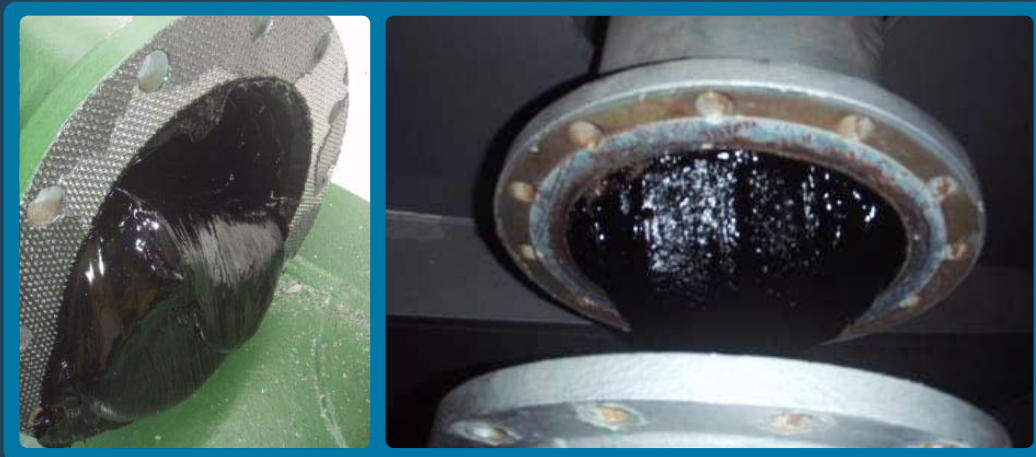
During a PAS Environmental Audit, the bunkering operation was in process and the Engineers together with the PAS Auditor noticed that the fuel bunkered was not properly directed to the forward HFO Tank. After further investigation, it was evidenced that the bunker line leading to the HFO Tank was blocked with solid fuel. In order to fix this, the Engineers started to dismantle parts of the bunker line with a view to clear it from the solidified fuel.

The problem occurred due to the improper line draining at the previous bunkering or transfer operation. In conjunction also with the prevailing low ambient temperatures of vessel's trading area, the fuel oil became solid and blocked the bunker line.

- Drain the bunker lines as necessary, upon completion of any bunkering or transferring operation.
- Ensure that the steam tracing of the bunker line, where installed, is maintained in good and effective condition.
- Circulate a fleet safety bulletin promoting seafarers' awareness regarding relevant precautions, when the vessel is trading in cold climates.
