## GAS WELDING AND CUTTING EQUIPMENT

### FINDING

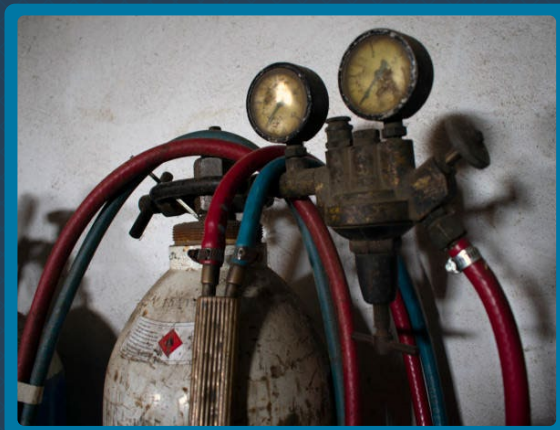
During an Engineering audit, the PAS auditor found the vessel's gas cutting/ welding equipment in poor condition. The gas cylinders had bends and deep scratches, while the manometers were damaged, obstructing clear visibility of pressure readings. Senior officers did not have maintenance records for the equipment available at the time of inspection.

- Check the Acetylene (AC)/Oxygen (OX) twin hose for cracks in the outer rubber and leaks before each use.
- The equipment components must be fully compatible and in accordance with applicable regulations and industry best practices for onboard use.
- Test the gas regulators and flashback arrestors annually.
- Replace gas regulators and flashback arrestors every 5 years.
- Ensure that a non-return valve is attached to the shank.
- Never try to overtight any nut of regulator connection or cylinder valve spindle to stop the leak.

- Verify that all safety equipment is procured from approved suppliers and accompanied by the necessary certifications.
- Develop guidelines for the onboard personnel on how to perform proper inspection and maintenance of all equipment parts.
- Run safety awareness campaigns to highlight the risks of using a poorly maintained gas welding/cutting equipment.
