# DON'T CURE PREVENT

ISSUE 23 JULY 2024

## FAILURE OF SCRUBBER OVERBOARD PIPE

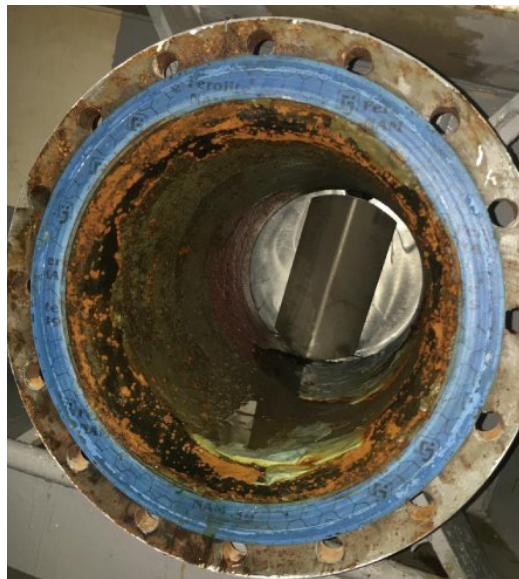
Severe leakages inside the engine room from the overboard scrubber pipe were observed during vessel's sea passage.

PAS was invited to conduct an incident investigation, where it was evidenced that the specifications of the inner coating of the pipe were not in accordance with industry standards. A thickness measurement, as part of the maintenance program, had not been conducted and the coating was found not resistant to chemicals.

- ✗ Inspection and maintenance of the overboard pipeline was not conducted, as necessary.
- ✗ The inner coating was not resistant to chemicals, and this caused severe corrosion.

- 🕒 On an annual basis, a qualified contractor must perform a thickness measurement to the overboard pipeline and joints or a diver inspection, depending on the design.
- 🕒 The inner coating of the overboard pipe must be certified as chemical resistant.
- 🕒 Always follow industry's standards and manufacturer's recommendations for the inspection and maintenance of such equipment.
