# DON'T CURE PREVENT

ISSUE 24 SEPTEMBER 2024

**OIL ACCUMULATION  
IN ENGINE ROOM**

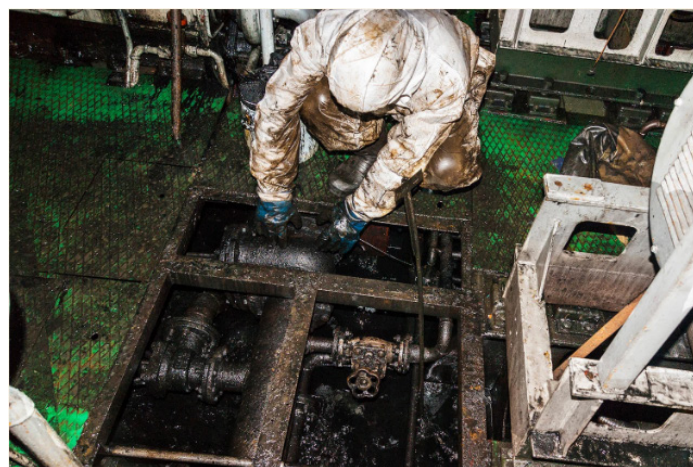
During an Environmental & Engine audit, the PAS Auditor observed various leakages in the engine room area. More specifically, oil found accumulated inside the drip trays and in bilges. The drip trays were dirty with dried oil, indicating inadequate maintenance and housekeeping practices.

- ✗ Poor housekeeping.
- ✗ Detected leakages were not rectified as soon as possible.
- ✗ Engine room bilges were dirty and it was not easy to identify any fresh leaks.
- ✗ Inadequate situational awareness and critical thinking.

The subject non-conformance posed significant risks, if not managed properly. The PAS Auditor recommended immediate cleaning of the drip trays and bilges to remove the accumulated oil and dirt.

- 🕒 Daily inspect the Engine Room machinery, equipment, pipelines and valves for identifying potential leakages.
- 🕒 Rectify detected leakages as soon as practically feasible.
- 🕒 Keep the Engine room bilges always clean and free of oil.
- 🕒 Paint the Engine room bilges in a light color to visually assist in identifying any new leak.
- 🕒 Always ensure that good housekeeping practices are followed.
- 🕒 Ensure adequate situational awareness and critical thinking.
- 🕒 Report such non-conformance to the company.

- ✅ Follow maintenance procedures in accordance with manufacturer's instructions and as per PMS.
- ✅ Perform a thorough inspection during the day and night safety rounds.
- ✅ Always clean and paint as necessary the drip trays and bilges to ensure proper identification of any leakages.
- ✅ Run a campaign to raise awareness and highlight the importance of critical thinking and situational awareness on the above matters.
- ✅ Conduct a thorough investigation for any identified source of oily water in the bilge or other leakages in the ER.
